Failure Analysis of Leaking Stainless Steel Pump Casing

Final Project Report Failure Analysis of Leaking Stainless Steel Pump Casing

Author: Marybeth Parker
Date: April 13, 2011

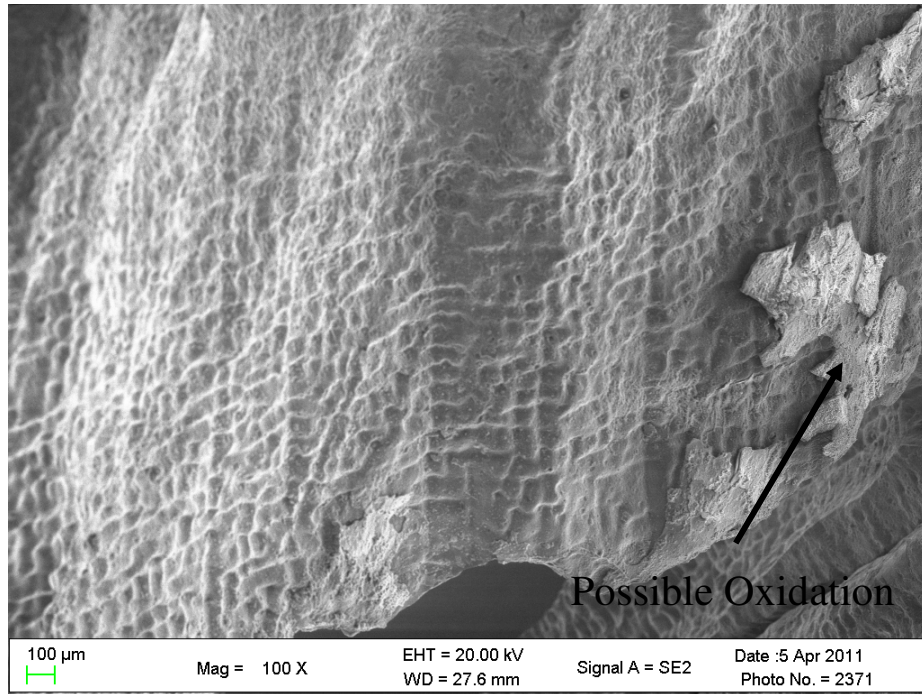
While these grain surfaces are smooth, other grains showed regular texture suggesting dendrites as shown in Figure 7. Some possible oxidation is also showing in this picture. Other parts of the fractured sample showed signs of corrosion on the surface grains as shown in Figure 8. None of these fracture surfaces shows signs of transgranular fracture such as microvoid coalescence, chevrons and other lines from crack propagation, or smooth flat faces from cleavage [2]. Intergranular fracture indicates that the bonds between grains were weaker than the grains themselves. If the grains were weaker than the grain boundaries, cracks would have traveled through them instead of around them. This is evidence for intergranular corrosion because this failure mechanism would have weakened the grain boundaries.

Figure 7: Micrograph taken at 100 X showing evidence of dendrites on grain surface.

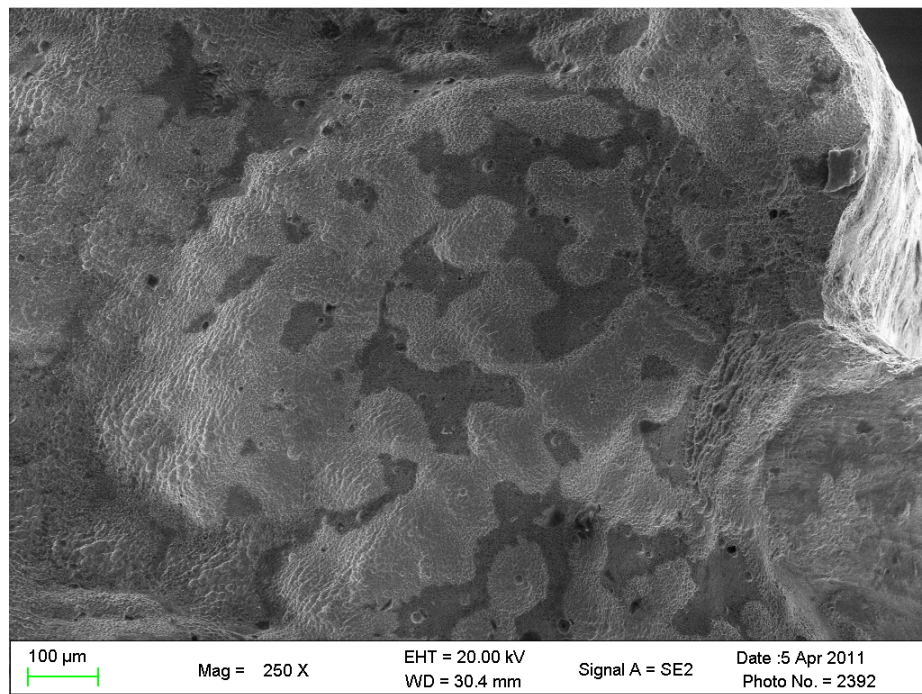
Figure 8: Micrograph taken at 100 x showing signs of corrosion on grain surface.
